Memo - Baseline Displacement / Brabantwater - Kruisland

Reference nr.: 2410023.03 / HM.AU.MV

Date: 09 Aug 2024

Executive summary

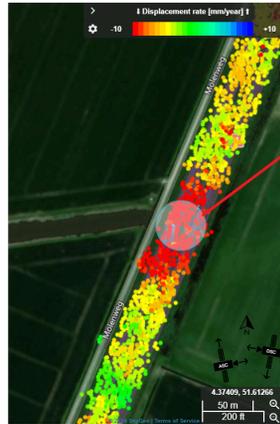
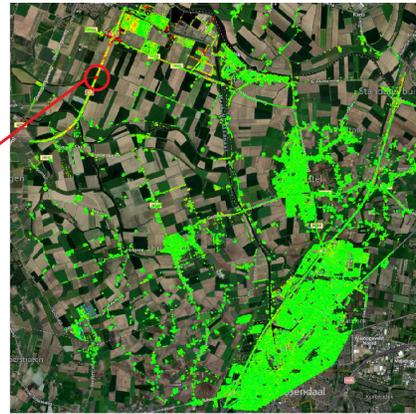
2. Shallow compaction over filled-in creek(roads) (A4 next to Potmarkreek)

The displacement rate on this road section is higher than neighboring areas, reaching up to velocities of ~ -12.5 mm/y, as compared to the rest of the road, which is around -3.7 mm/y.

Description: On this road, a localized higher subsidence velocity is observed. This correlates with the location of a former Creek that has been filled-in. The disturbed soil layers tend to compact over time. Initially, this compaction can be rapid but typically decelerates as the soil reaches a new equilibrium. Soil settling is a natural consequence of the re-compaction process after being disturbed.

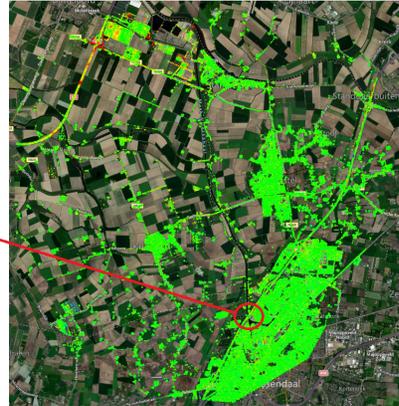
3. Seasonality due to thermal expansion (Brug Zuid Hollandweg over Nieuwe Roosendaalsche vliet)

Seasonal variations are around 5 - 7 mm, which is not the case for the surrounding areas, with mainly linear displacements.

Description: Seasonality is observed where temperature is expected to play a role. Thermal expansion and contraction of materials (such as asphalt in roads, steel in bridges, and some building materials) lead to cyclic displacements. These movements are usually periodic, corresponding to seasonal temperature variations. In this case, subsidence and uplift correspond to winter and summer periods.

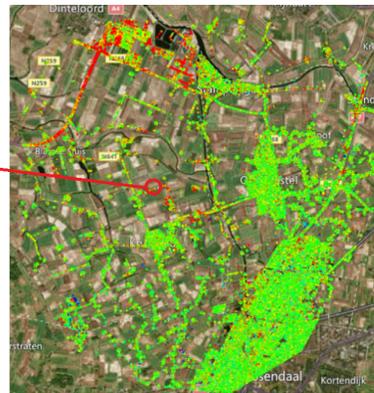
4. Generic long-term shallow compaction (Tweede Boutweg, Kruisland)

The displacement can be very localized and can correlate with local soil type. The displacement rates can be between ~ -2.5 and -6 mm/y

Description: Overall, we observe gradual and continuous subsidence due to natural soil compaction processes. Factors contributing include soil consolidation under the weight of overburden and ongoing sedimentary processes, common in The Netherlands.

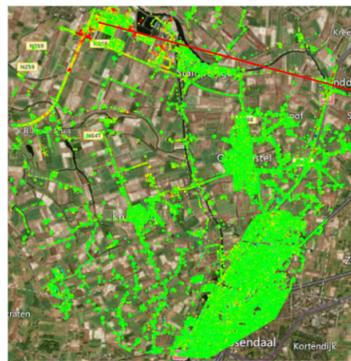
**6. Greenhouses.
(Noordzeedijk
120, Dinteloord).**

Description: On the roof of the greenhouses, the displacement rate reaches up to velocities of ~ -12 mm/y. This displacement indicates that the structure most likely does not have a deeper foundation. The spatial difference most likely indicates spatial variations in the soil properties and the corresponding bearing capacity and/or compaction. In the time series also a seasonal effect can be seen which corresponds to the thermal expansion of the metal structure of the greenhouse and shows opposite signals for the different satellite-tracks due to the different look-direction.

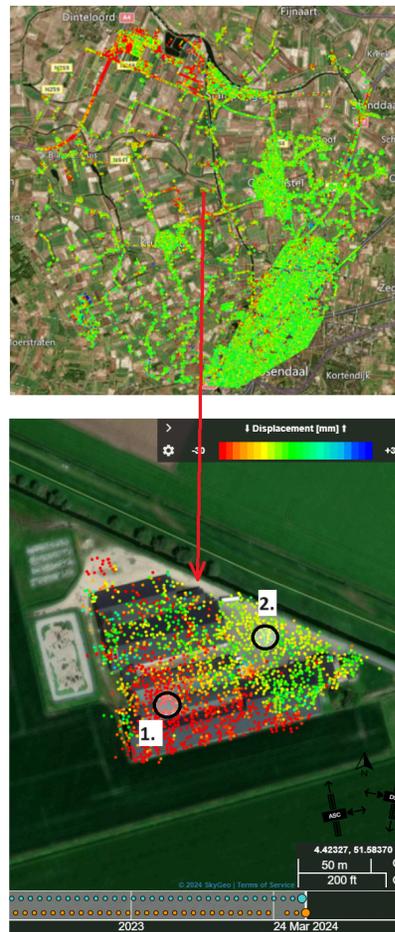
7. Displacement Magnitude Differences in Urban Areas: Impact of Foundation Types (Kleine Bolspolder 3, Kruisland)

Description: We observe different displacement magnitudes within the same location. Time series show that the barn (1), exhibits more than twice as much displacement (up to ~5 mm/yr) as the terrain next to it (up to ~2 mm/yr). The reason for this can be local variations in soil properties and compaction occurring due to the additional load of the barn.
